SAVE THE BAYS REPORT: OCTOBER 10, 2019

REPORT: Observations from the Equinor Oil Spill By Save the Bays

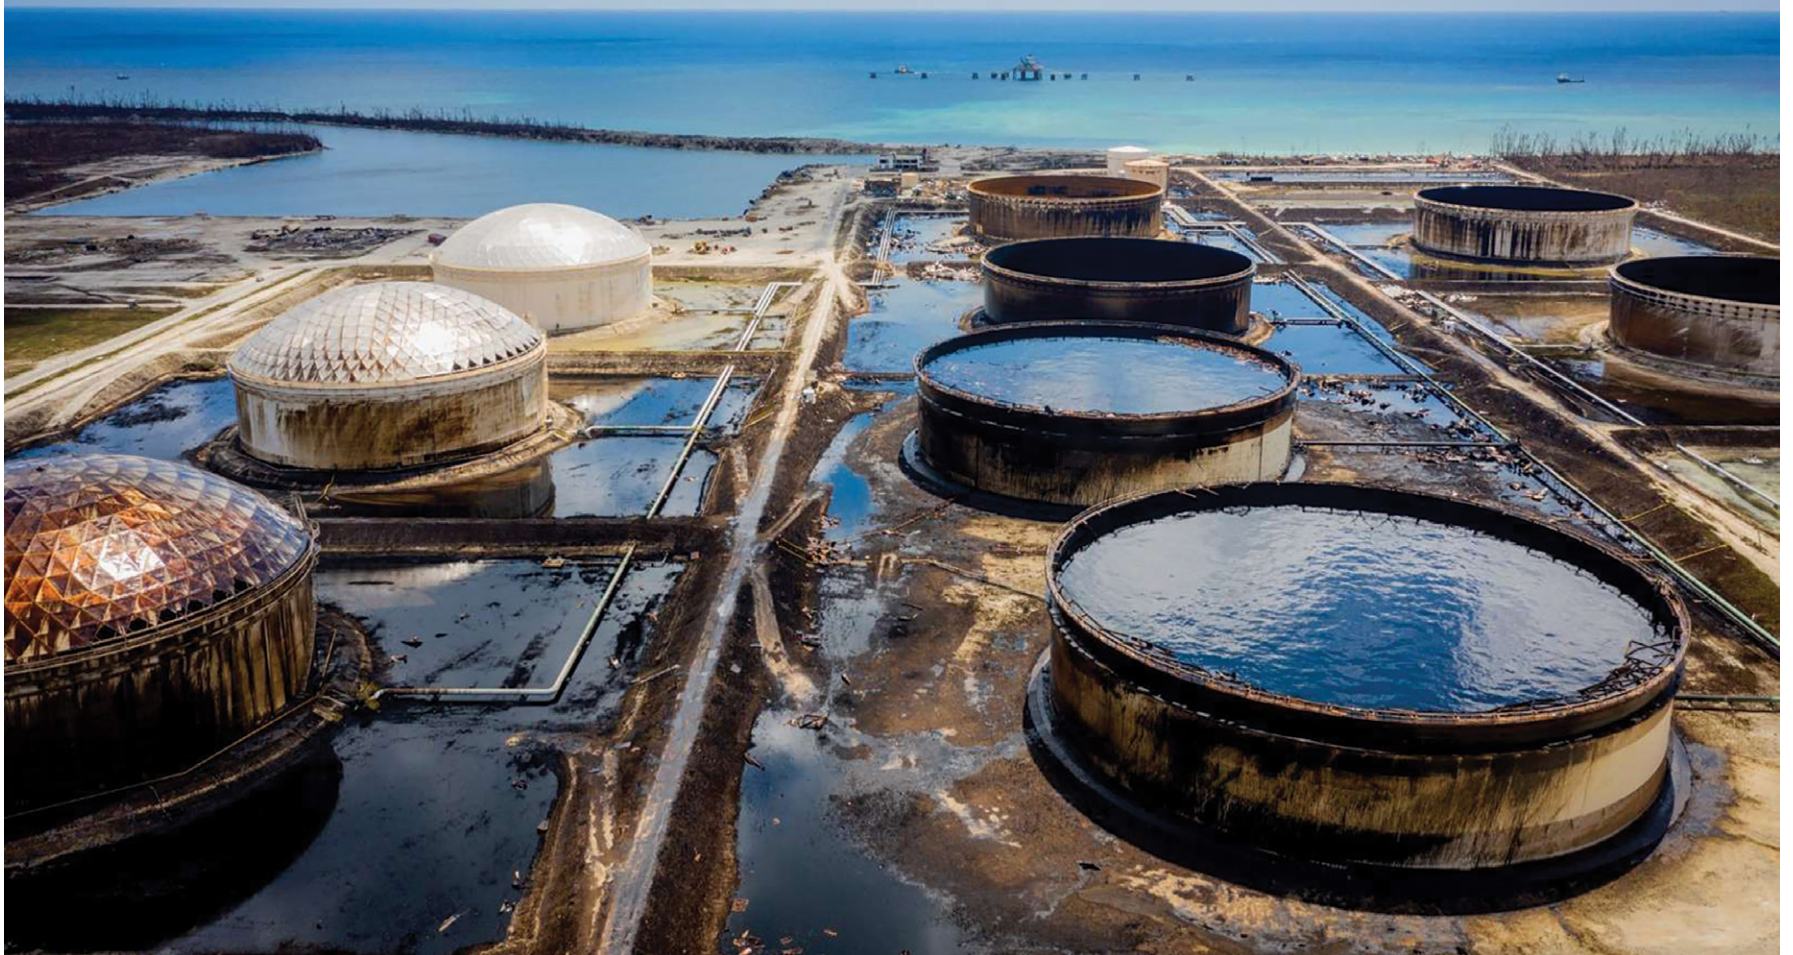
Oil soaked land outside Equinor's holding walls just after the passage of Hurricane Dorian

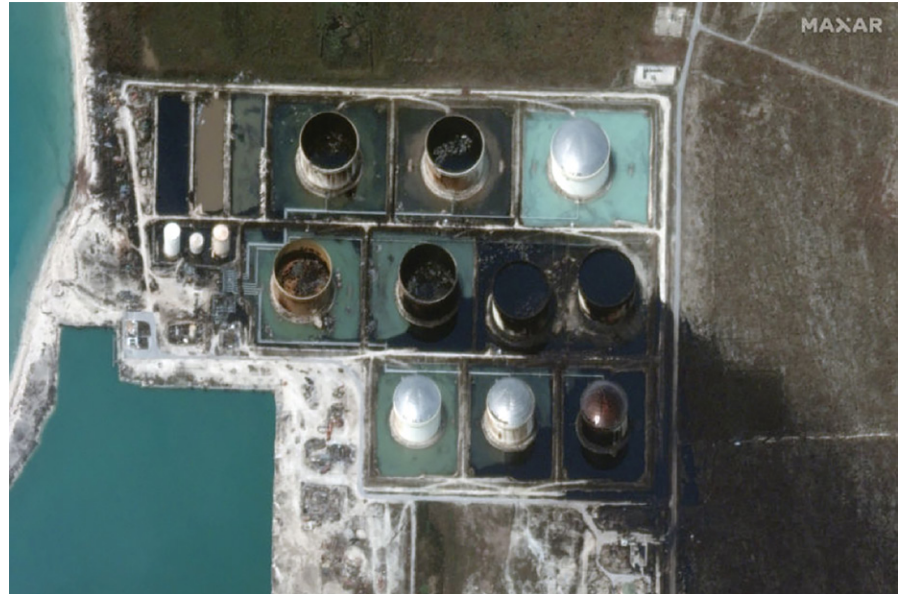
Figure 1 – Aerial photograph of the Equinor tank farm after Hurricane Dorian

Equinor operates 10 crude ASTs, 6 of which sustained considerable wind damage during Hurricane Dorian. Satellite and aerial photographs show that the roofs of those 5 tanks were blown off, see Figure 1. It appears that the majority of the oil leak has originated from the second tank from the left in the middle row. The tank roofs were blown off the first 2 tanks from the left in the upper row, but no spillage can be seen. It appears that these tanks were partially filled. Had there been a more significant storm surge, these tanks would have collapsed, resulting from buckling of the tank shell.

It further appears that the first tank on the left in the middle row was empty at the time of the hurricane, and in fact probably has not been used in a while (evidence of rust inside the tank). The 2 tanks at the right in the middle row appear to be full, so although the roofs were blown off, little appeared to have been spilled from these 2 tanks.

The bottom 3 tanks are intact. The photograph clearly shows the direction of the spill in the north-east direction. Note that during the second part of hurricane, the eye stalled around Freetown/High Rock with the winds

coming from the south west. Probably it is at that point of the storm when the roofs blew off.

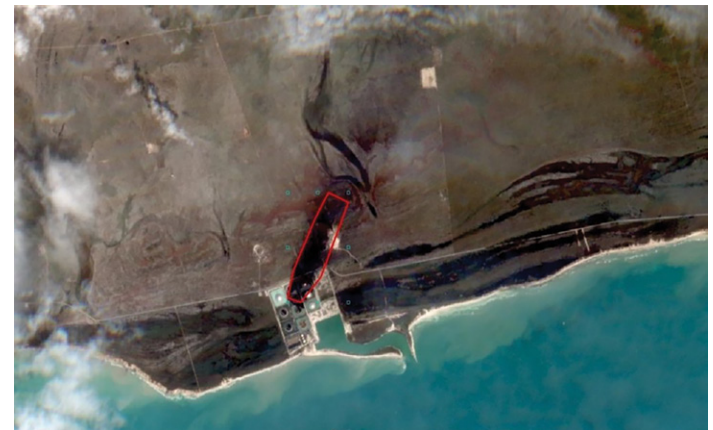
Figure 2. is a satellite photograph showing the extent of the crude oil spill. The direction of the spill suggests that at the moment the risk of contaminating the water is small as long as Equinor can stabilize the 2 tanks that are full but without roof. In the absence of a roof, the tanks must be emptied as soon as possible. Heavy rains could cause the tanks to overflow with a chance that the crude flow into the water.

Figure 2 – Satellite photograph showing the extent of the spill

- a. An important part of spill prevention is secondary containment in the form of walls or levies. It appears that the secondary containment was not sufficient to contain the content of one tank. Moreover, Figure 2 shows that 2 tanks (2 right-side tanks in the middle row) were within one retaining wall. If one tank would have collapsed the second tank would have surely failed and the existing wall would be insufficient to contain the crude oil.
- b. The tanks appear to be too close together.

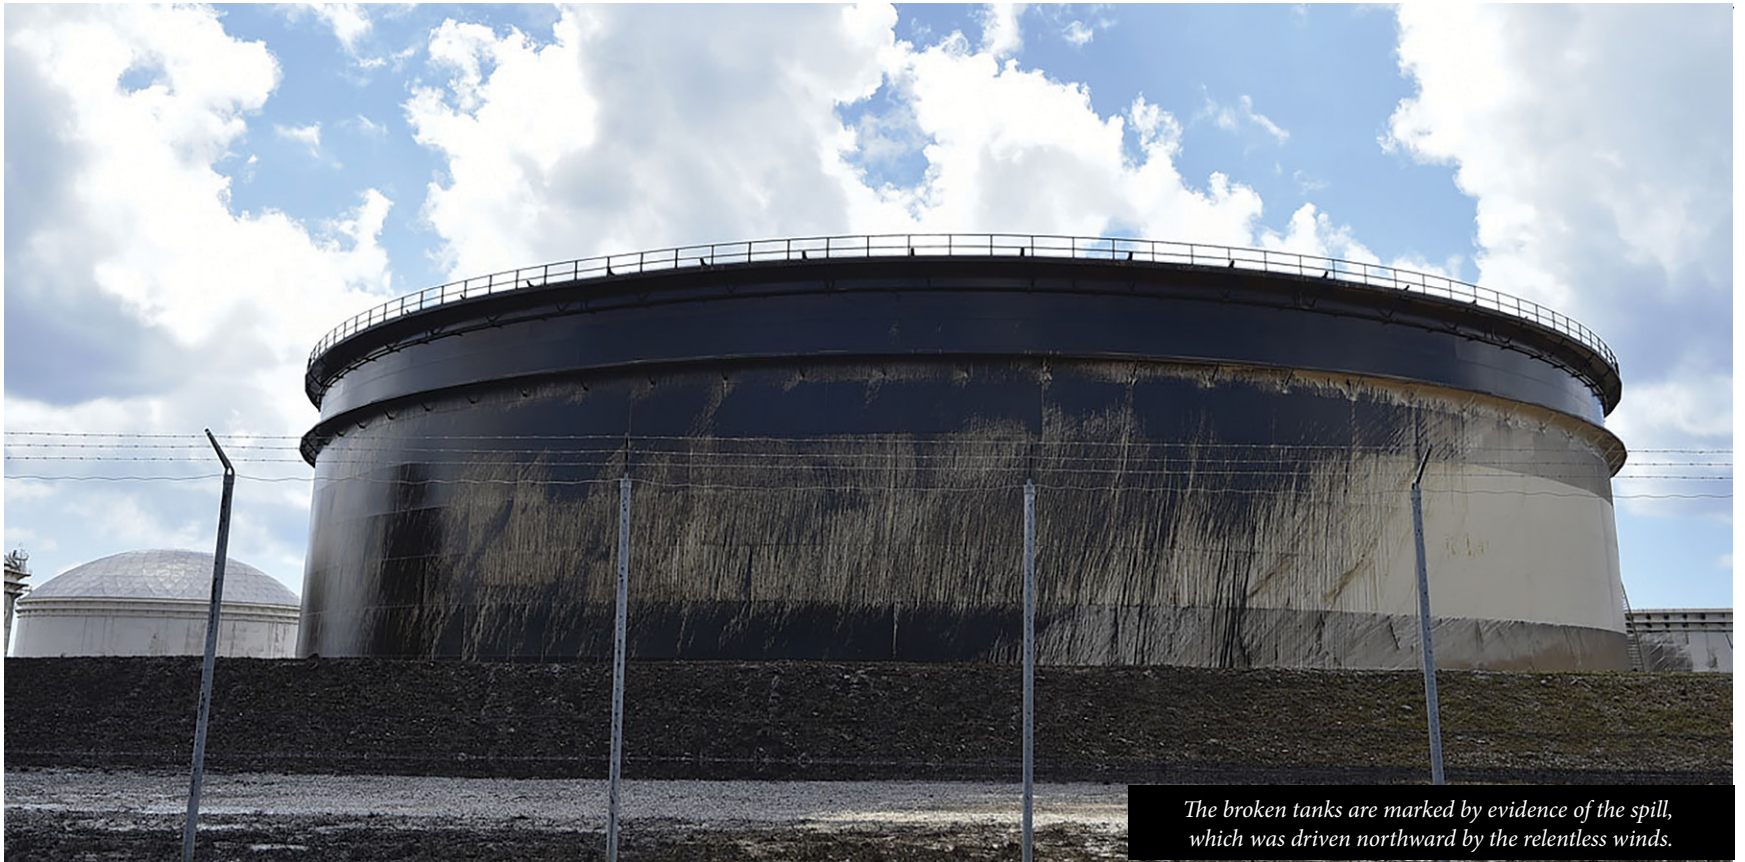
The broken tanks are marked by evidence of the spill, which was driven northward by the relentless winds.

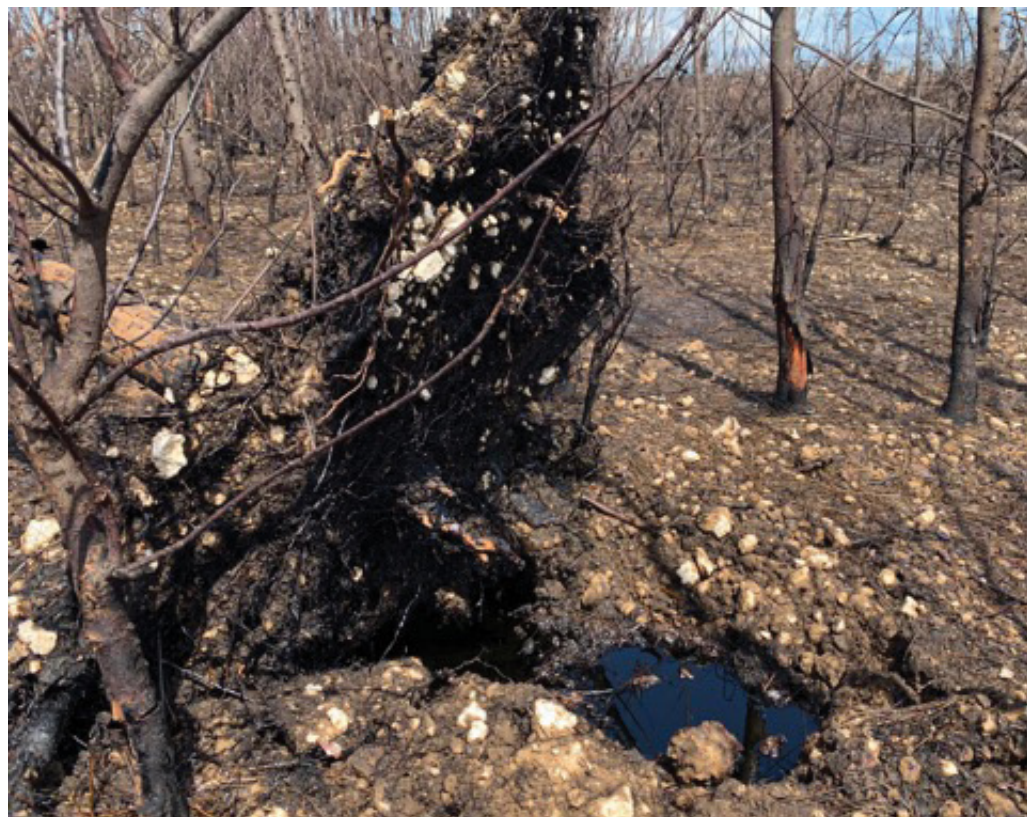
Figure 4: Oil settling into crevices and holes in the pine forest north of the spill site

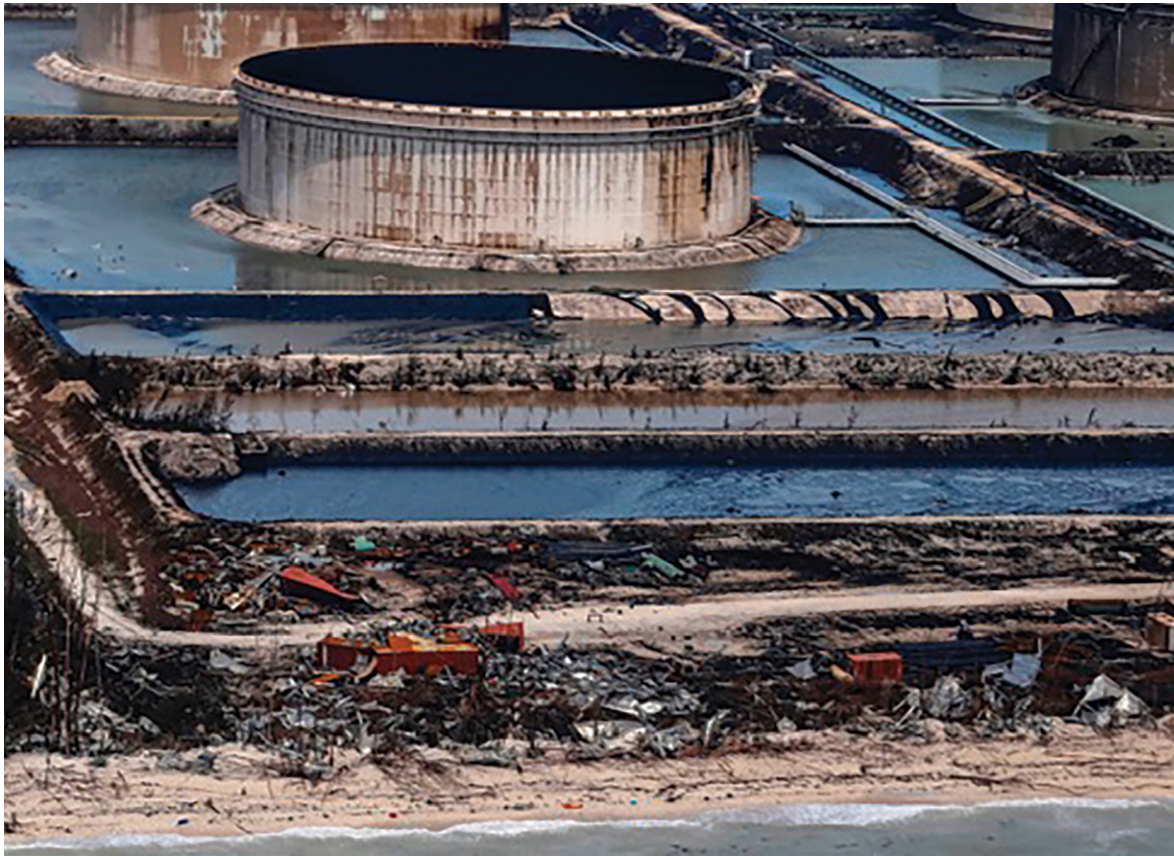
Figure 5: One of the tanks that lost its roof during the storm.

- a. While a category 5 hurricane results in extremely high forces, the roof on each tank should have been designed such that it could withstand the wind force, particularly in light of the fact that the tanks are in an environmentally sensitive area. The tank roofs must be able to withstand 200+ mph winds.
