UNITED STATES DISTRICT COURT
FOR MIDDLE DISTRICT OF LOUISIANA

Civ. No. 3:18-cv-00023-SDD-EWD

DECLARATION OF
DEAN WILSON

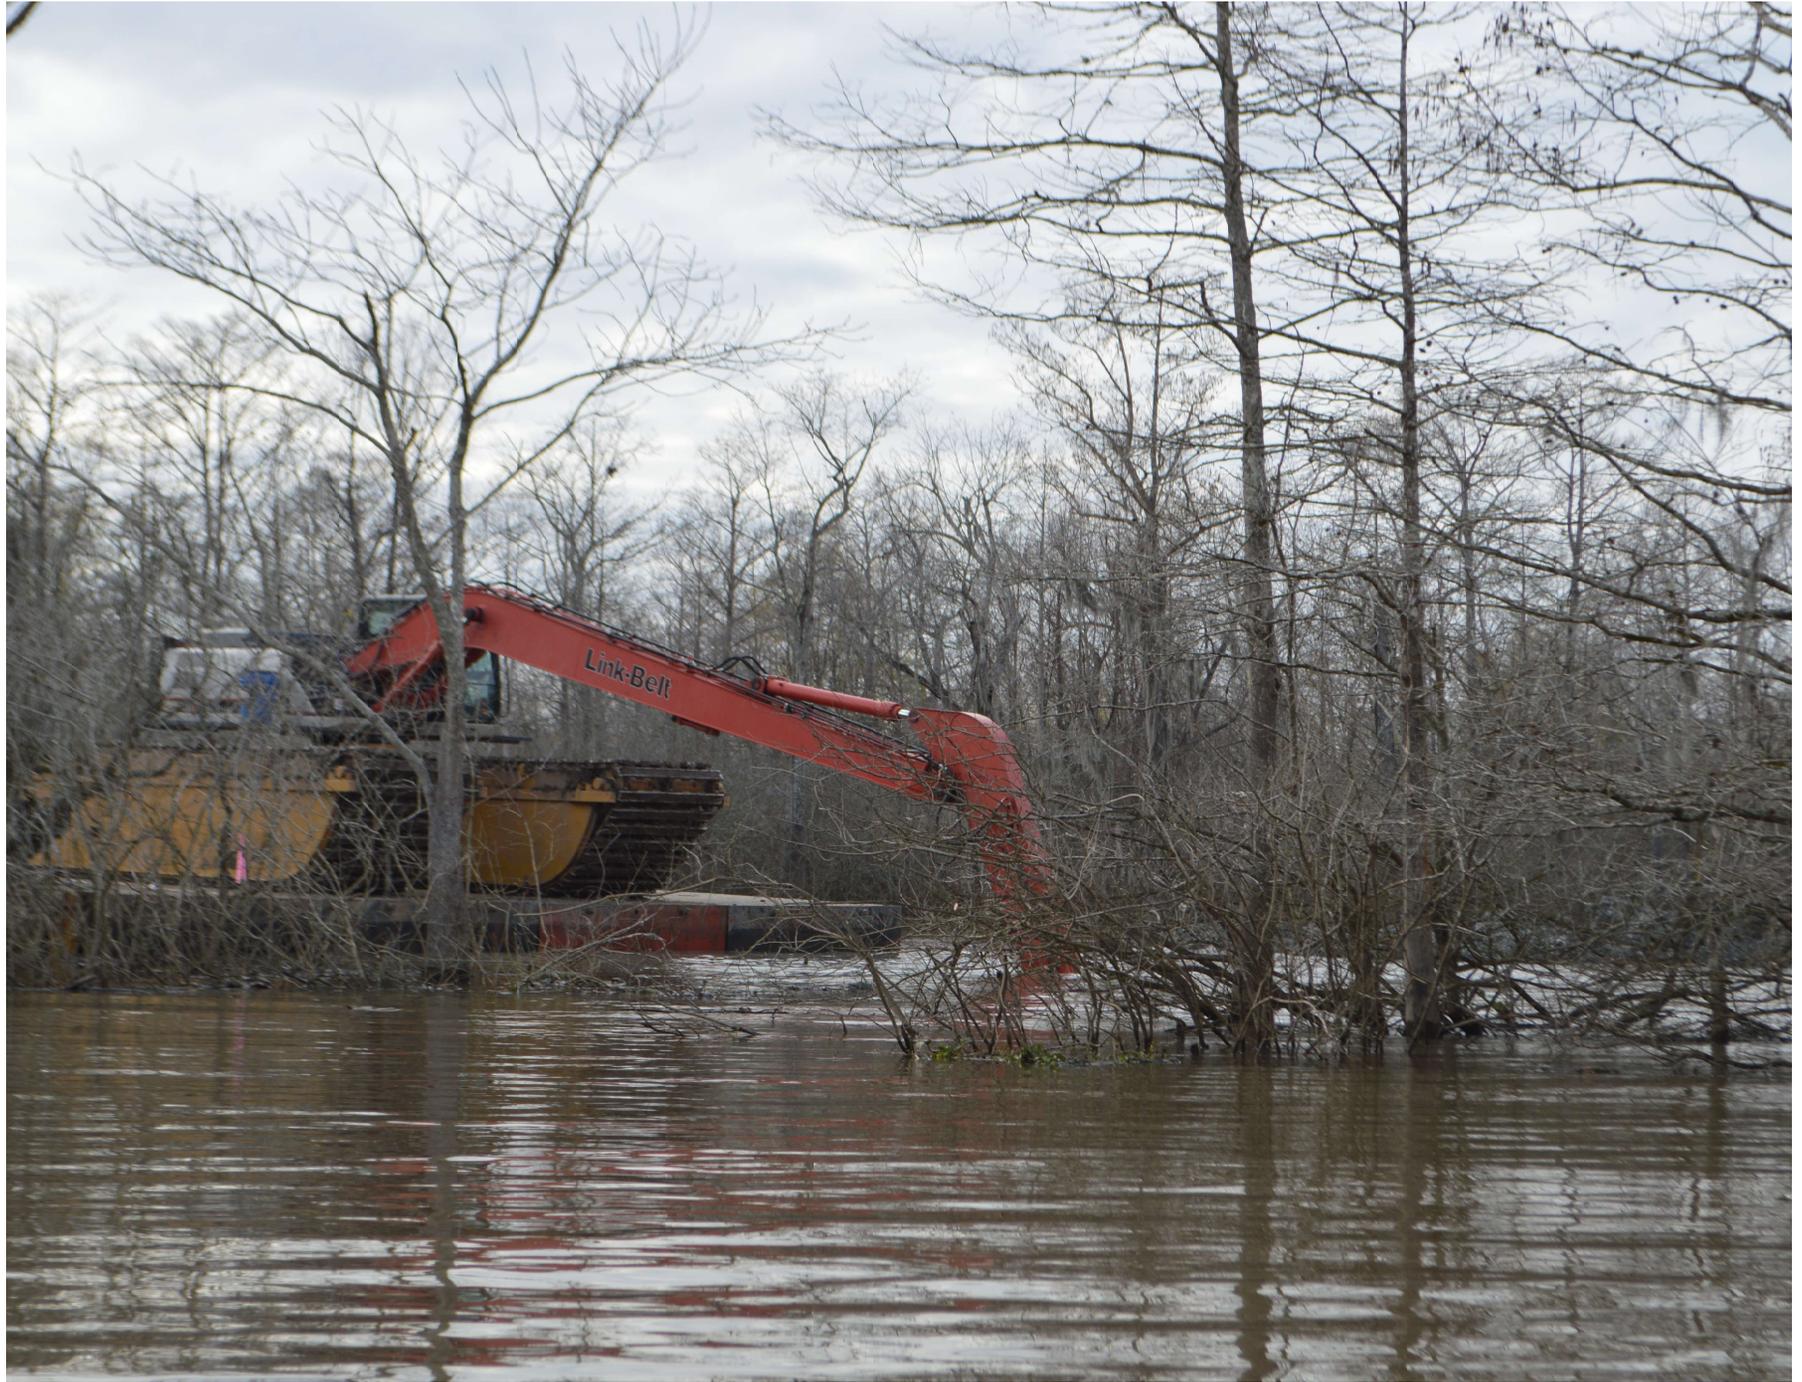
Exhibit 1

5. Subsequent to my last declaration, on January 16, 2019 I traveled into the Basin by boat again, to inspect the Bayou Bridge pipeline right of way. On the day of this visit, water levels in the Basin were very high. According to USGS data, the water height at the Carrollton Gage was 15.0 feet on that day. When water levels are this high, water moves through the swamp and especially any pipeline channels quickly. The higher the water level, the faster the current. During this trip, I observed an excavator in the right of way, actively digging in a trench and creating a new spoil bank with the spoils it was removing from the trench. Included as Exhibits 1 through 3, are photographs I took of the excavator engaging in this activity. I took these photographs approximately 2.3 miles west of the Intracoastal Waterway that runs next to the eastern Atchafalaya levee. Geographic coordinates for the location where I took these images are 30° 05' 19.61" N, and 91° 22' 07.46" W. I took these photographs between 4:00pm and 5:00pm in the afternoon on January 16, 2019.

6. The photographs document what I observed on that date: an excavator on a floating barge actively digging into the bottom of the cypress swamp. Excavation from a floating barge was presumably chosen because the water level at that time was so high that it was too deep to place excavation equipment. As I observed, the excavator arm sinks deep into the water, nearly fully submerged, to reach the bottom. It then pulls the bucket out of the water, which is filled with dark mud, as rivers of sediment-laden water and mud cascade out the sides and fall back into the water. The excavator then dumps this mud onto a newly formed pile of spoil, creating a new spoil bank that in places was taller than the water height.

8. During my January 16, 2019, visit, I observed no erosion controls employed—no silt fences, sediment traps, straw bales or other controls. Sediment was flowing freely from the site into the surrounding wetlands and downstream. The photographs I took document the absence of these protective controls. My observations on January 16 were consistent with many of the other observations I have made over the past year, in which erosion control measures were not in use. In all of my visits to observe construction on the Bayou Bridge pipeline right of way, the majority of which occurred during “high water conditions” as defined by the Permit, I have never seen Bayou Bridge use erosion control measures along the trench or spoil bank in the pipeline right of way.

- Exhibit 1: January 16, 2019 photograph of the excavator approximately 2.3 miles west of the Intracoastal Waterway that runs next to the eastern Atchafalaya levee. Geographic coordinates for this image is 30° 05'19.61" N, and 91° 22'07.46" W.

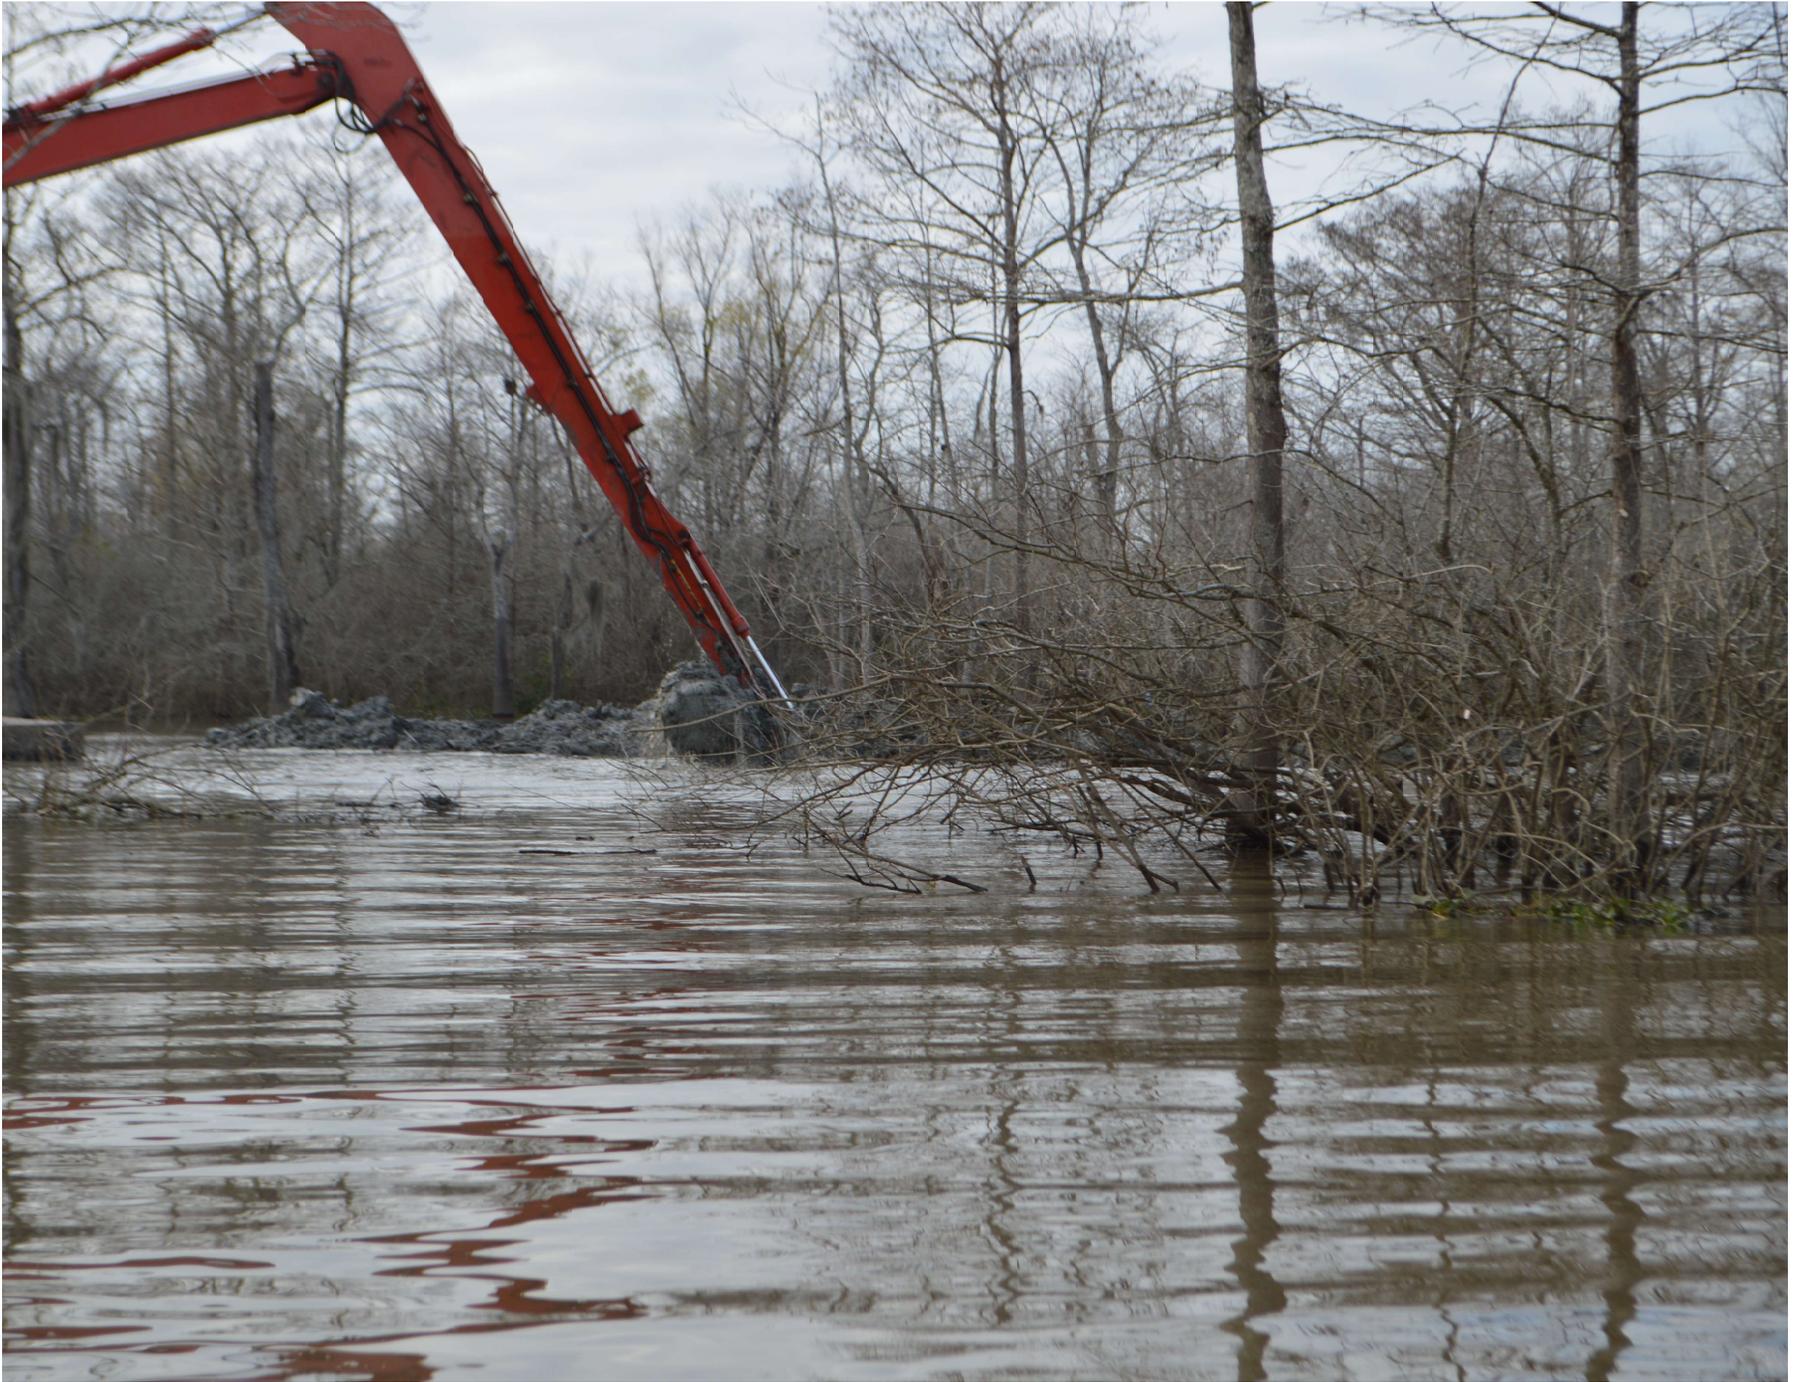
Exhibit 2

- Exhibit 2: January 16, 2019 photograph of the excavator approximately 2.3 miles west of the Intracoastal Waterway that runs next to the eastern Atchafalaya levee. Geographic coordinates for this image is 30° 05'19.61" N, and 91° 22'07.46" W.

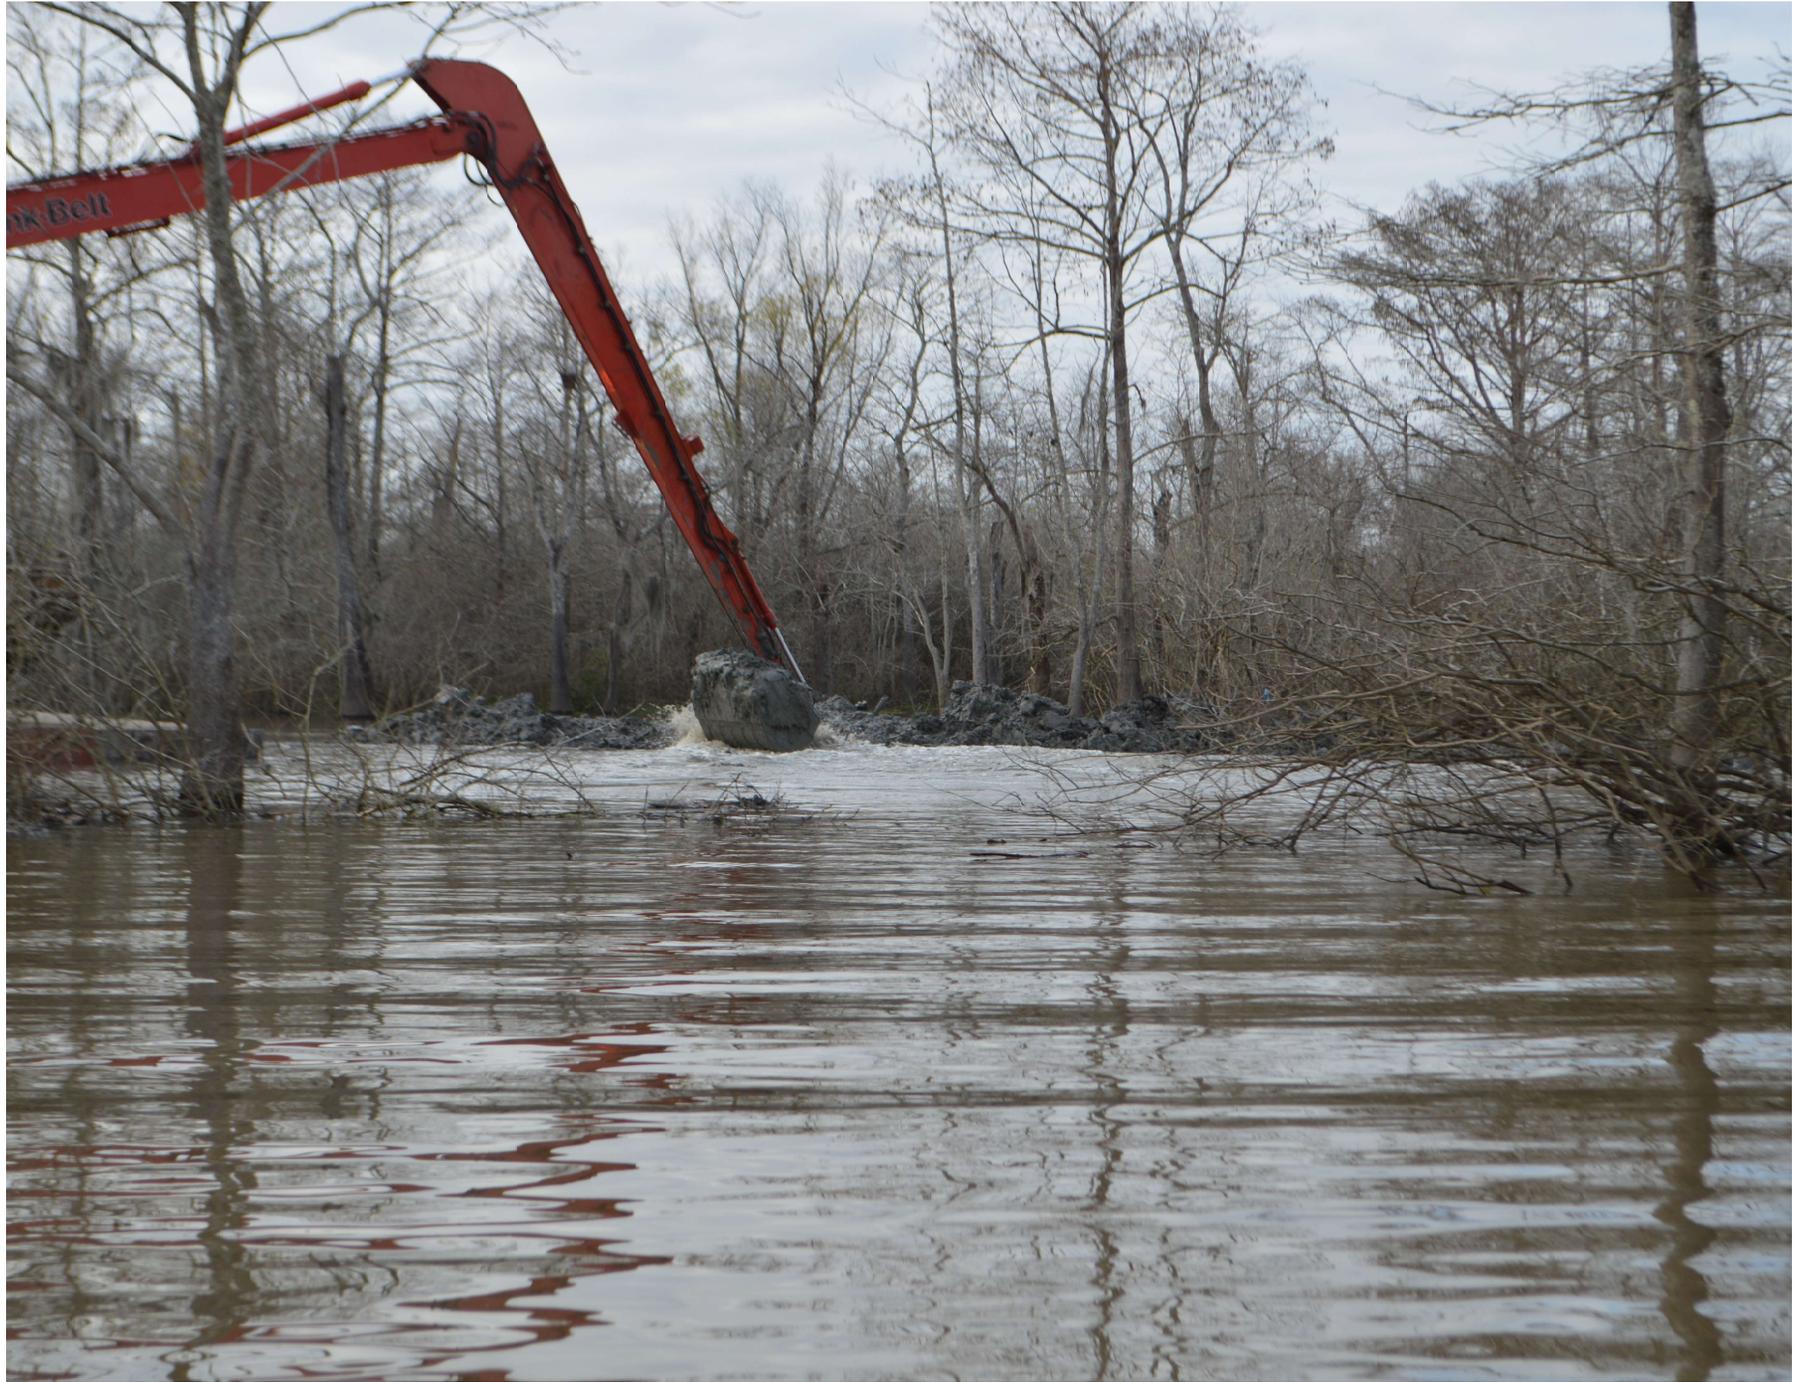
Exhibit 3

- Exhibit 3: January 16, 2019 photograph of the excavator approximately 2.3 miles west of the Intracoastal Waterway that runs next to the eastern Atchafalaya levee. Geographic coordinates for this image is 30° 05'19.61" N, and 91° 22'07.46" W.

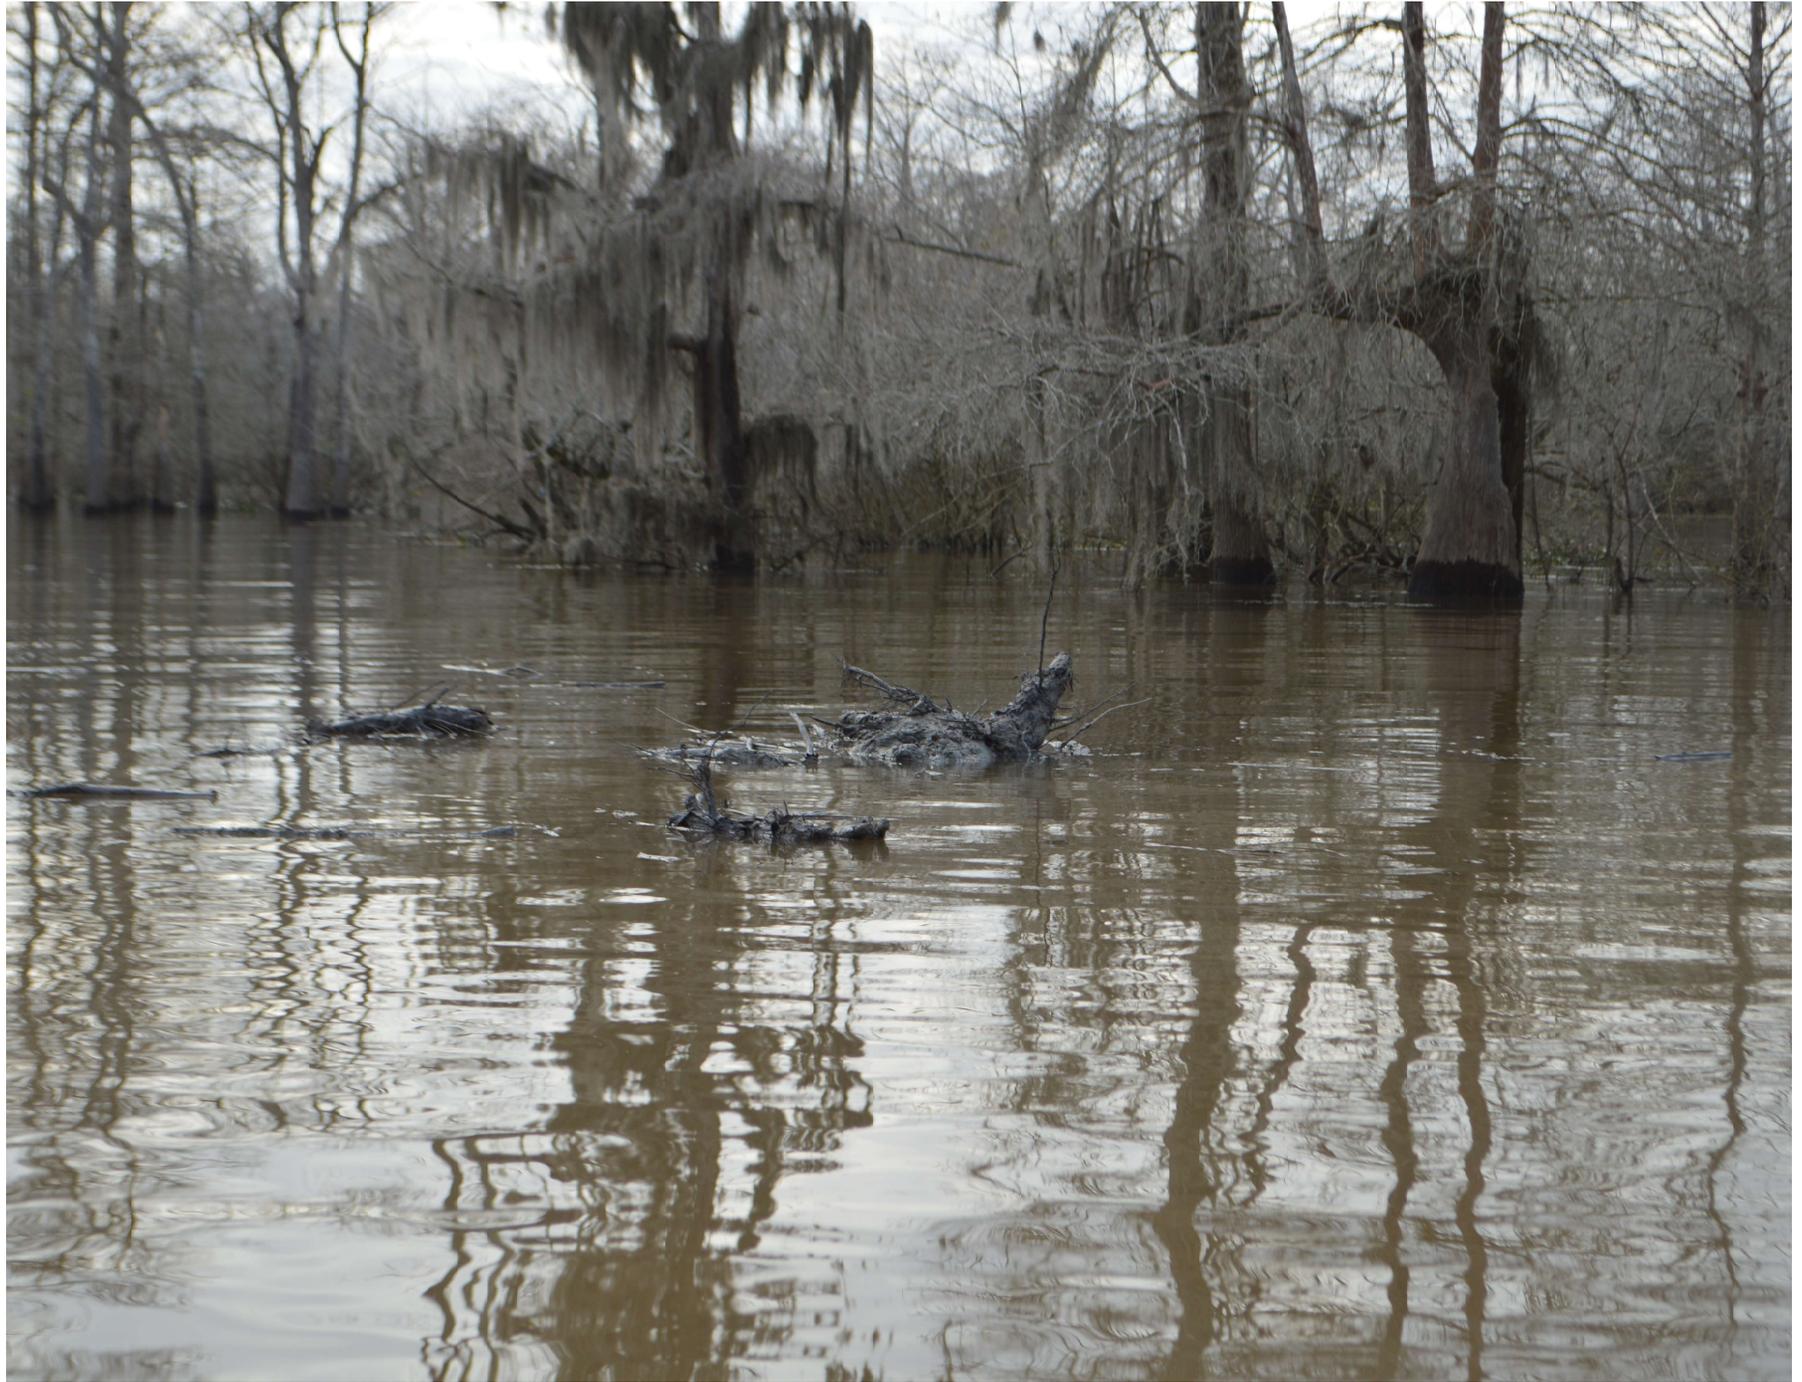
Exhibit 4

7. I observed a trail of mud and woody debris carried by the current that was traveling away from the construction site, and degrading water quality. I witnessed clods of mud and other debris floating away in the rapidly moving water. Ordinarily, when I see branches and

other debris in the river, they are free from mud or sediment. Here, however, dark sticky mud covers these branches in chunks, indicating they were pulled from the bottom of the river. Included as Exhibit 4, is a close up photograph of this woody debris from the construction site. I took this photograph at the same time and location as the other photographs.

- Exhibit 4: January 16, 2019 photograph of the woody debris from the construction site.
- Exhibit 5: January 17, 2019 photograph of the facility with the warnings partially submerged beneath high water.

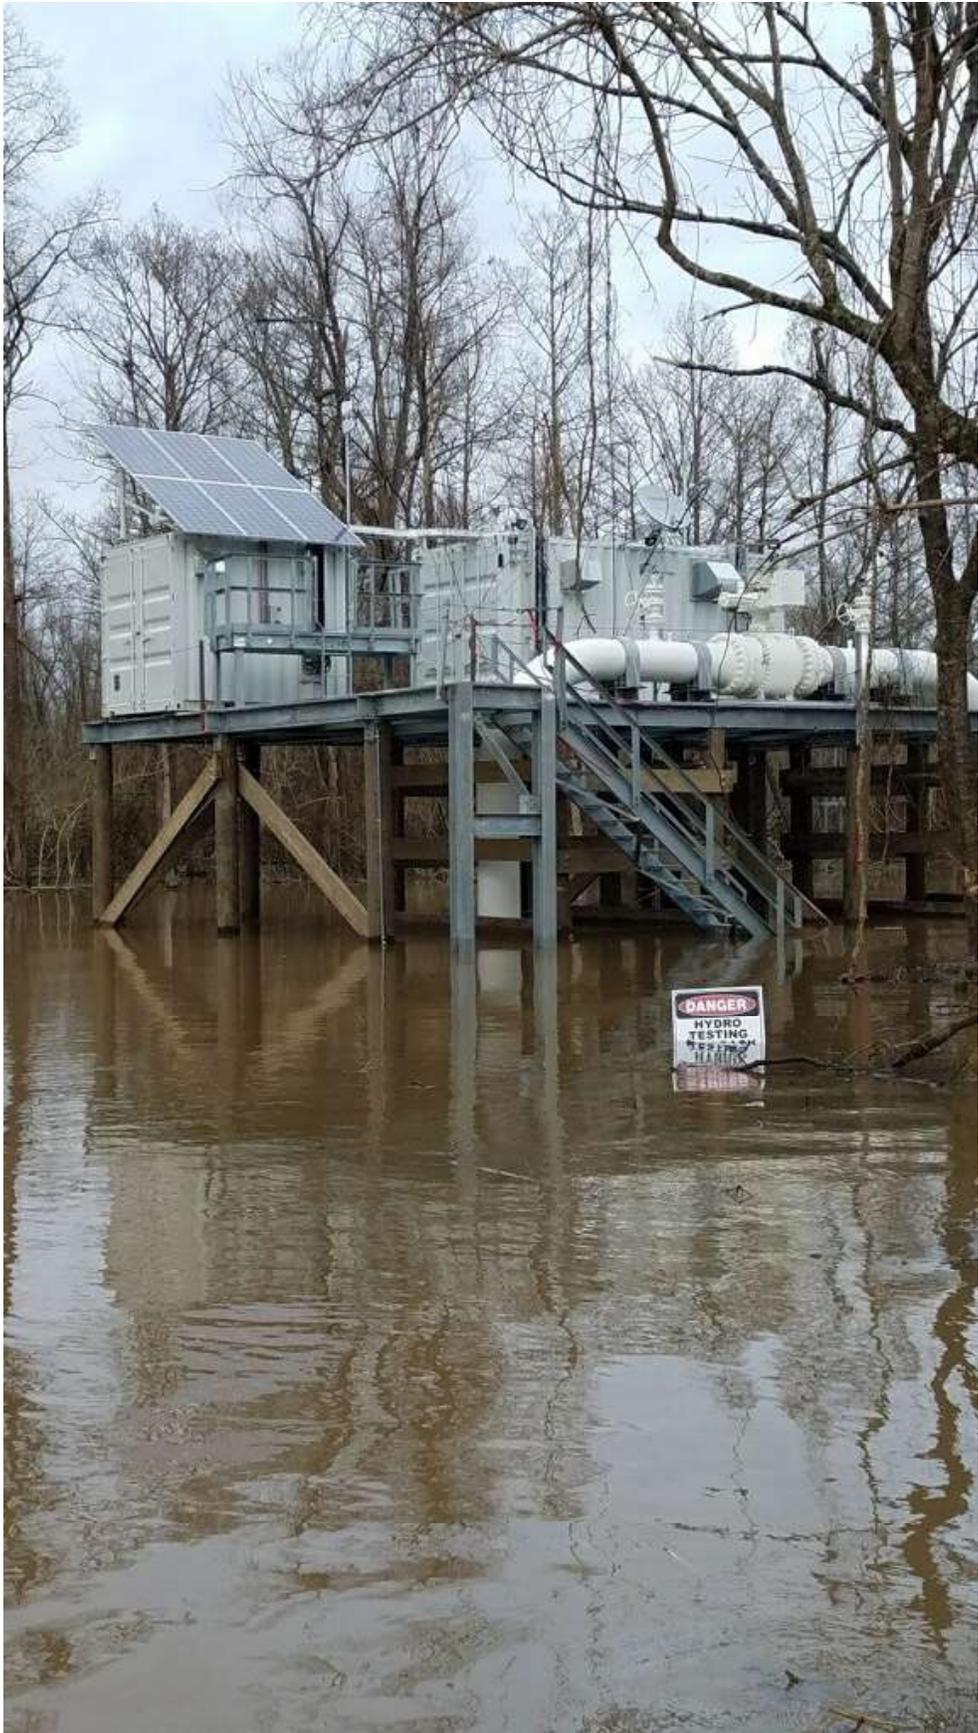
Exhibit 5

above ground facility a few hundred yard west of the Intercoastal Waterway adjacent to the eastern levee, at 30°05'26.33" N and 91°19'5.45" W. The company posted warning signs on that facility stating they are conducting pressure testing. Included as Exhibit 5, is a photograph of the facility with the warnings partially submerged beneath the high water. My son took this photograph on January 17, 2019. BBP has also post indicating a pipeline is already in the right-of way for much of this section of the pipeline.

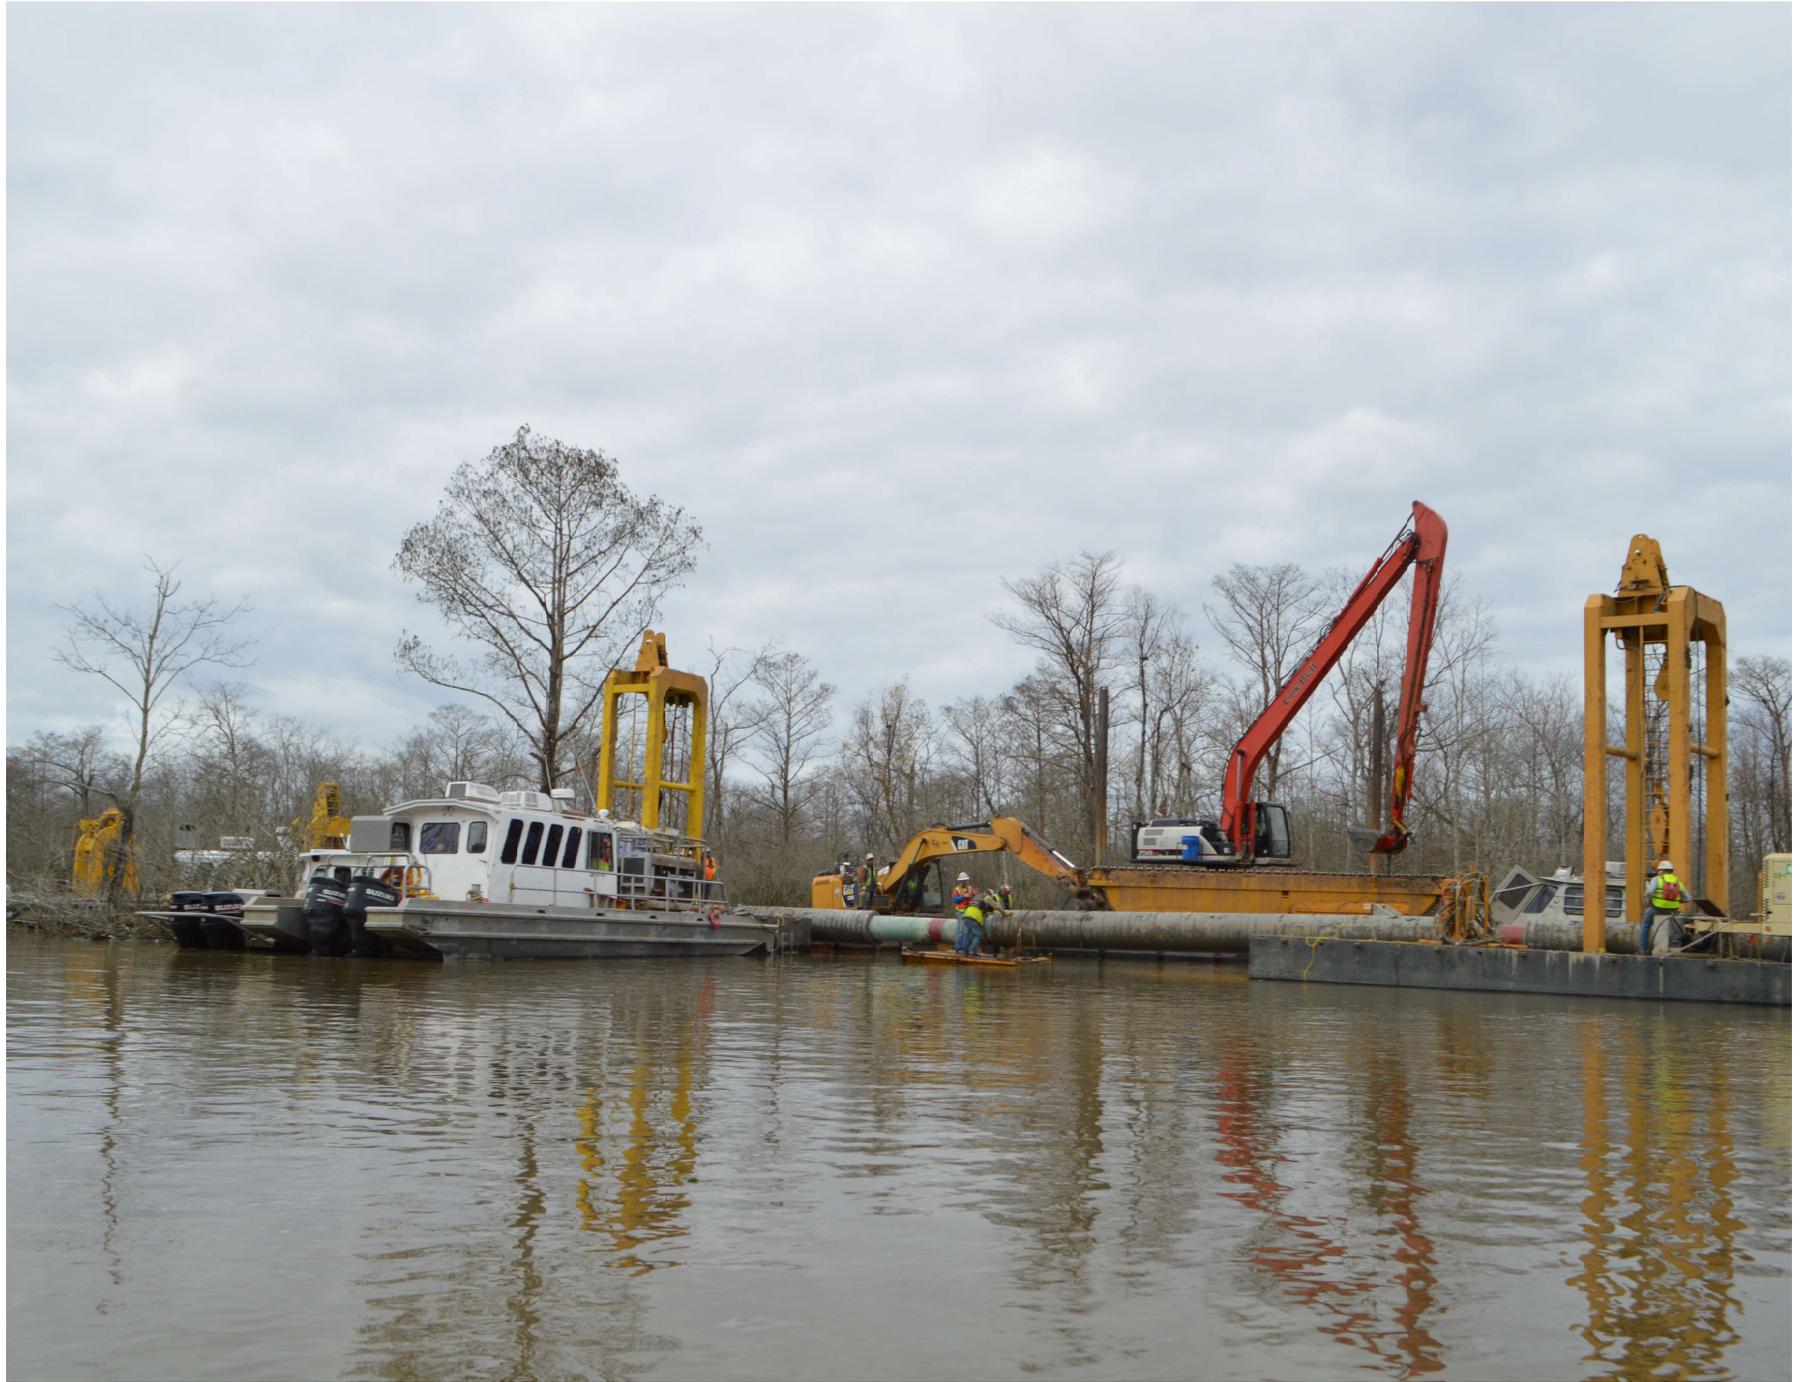
Exhibit 6

11. On January 22, 2019, I inspected the Bayou Bridge pipeline right of way again at the same location where I previously observed trenching activity. During this inspection, I observed that a work crew had lifted a section of the pipeline out of the water, and was conducting welding operations on the pipeline. Two excavators were visible in the background. Included as Exhibit 6, is a photograph of the pipeline lifted above ground with barge equipment and excavators in the background. No silt fences or other erosion control measures are visible. During this inspection, I again observed the newly created spoil bank in the right of way. A photograph of this spoil bank is included as Exhibit 7. Both of these photographs were taken at 30° 05' 19.61" N, and 91° 22' 07.46" W on January 22, 2019.

- Exhibit 6: January 22, 2019 photograph of the pipeline lifted above ground with barge equipment and excavators in the background located at 30° 05'19.61" N, and 91° 22'07.46" W.

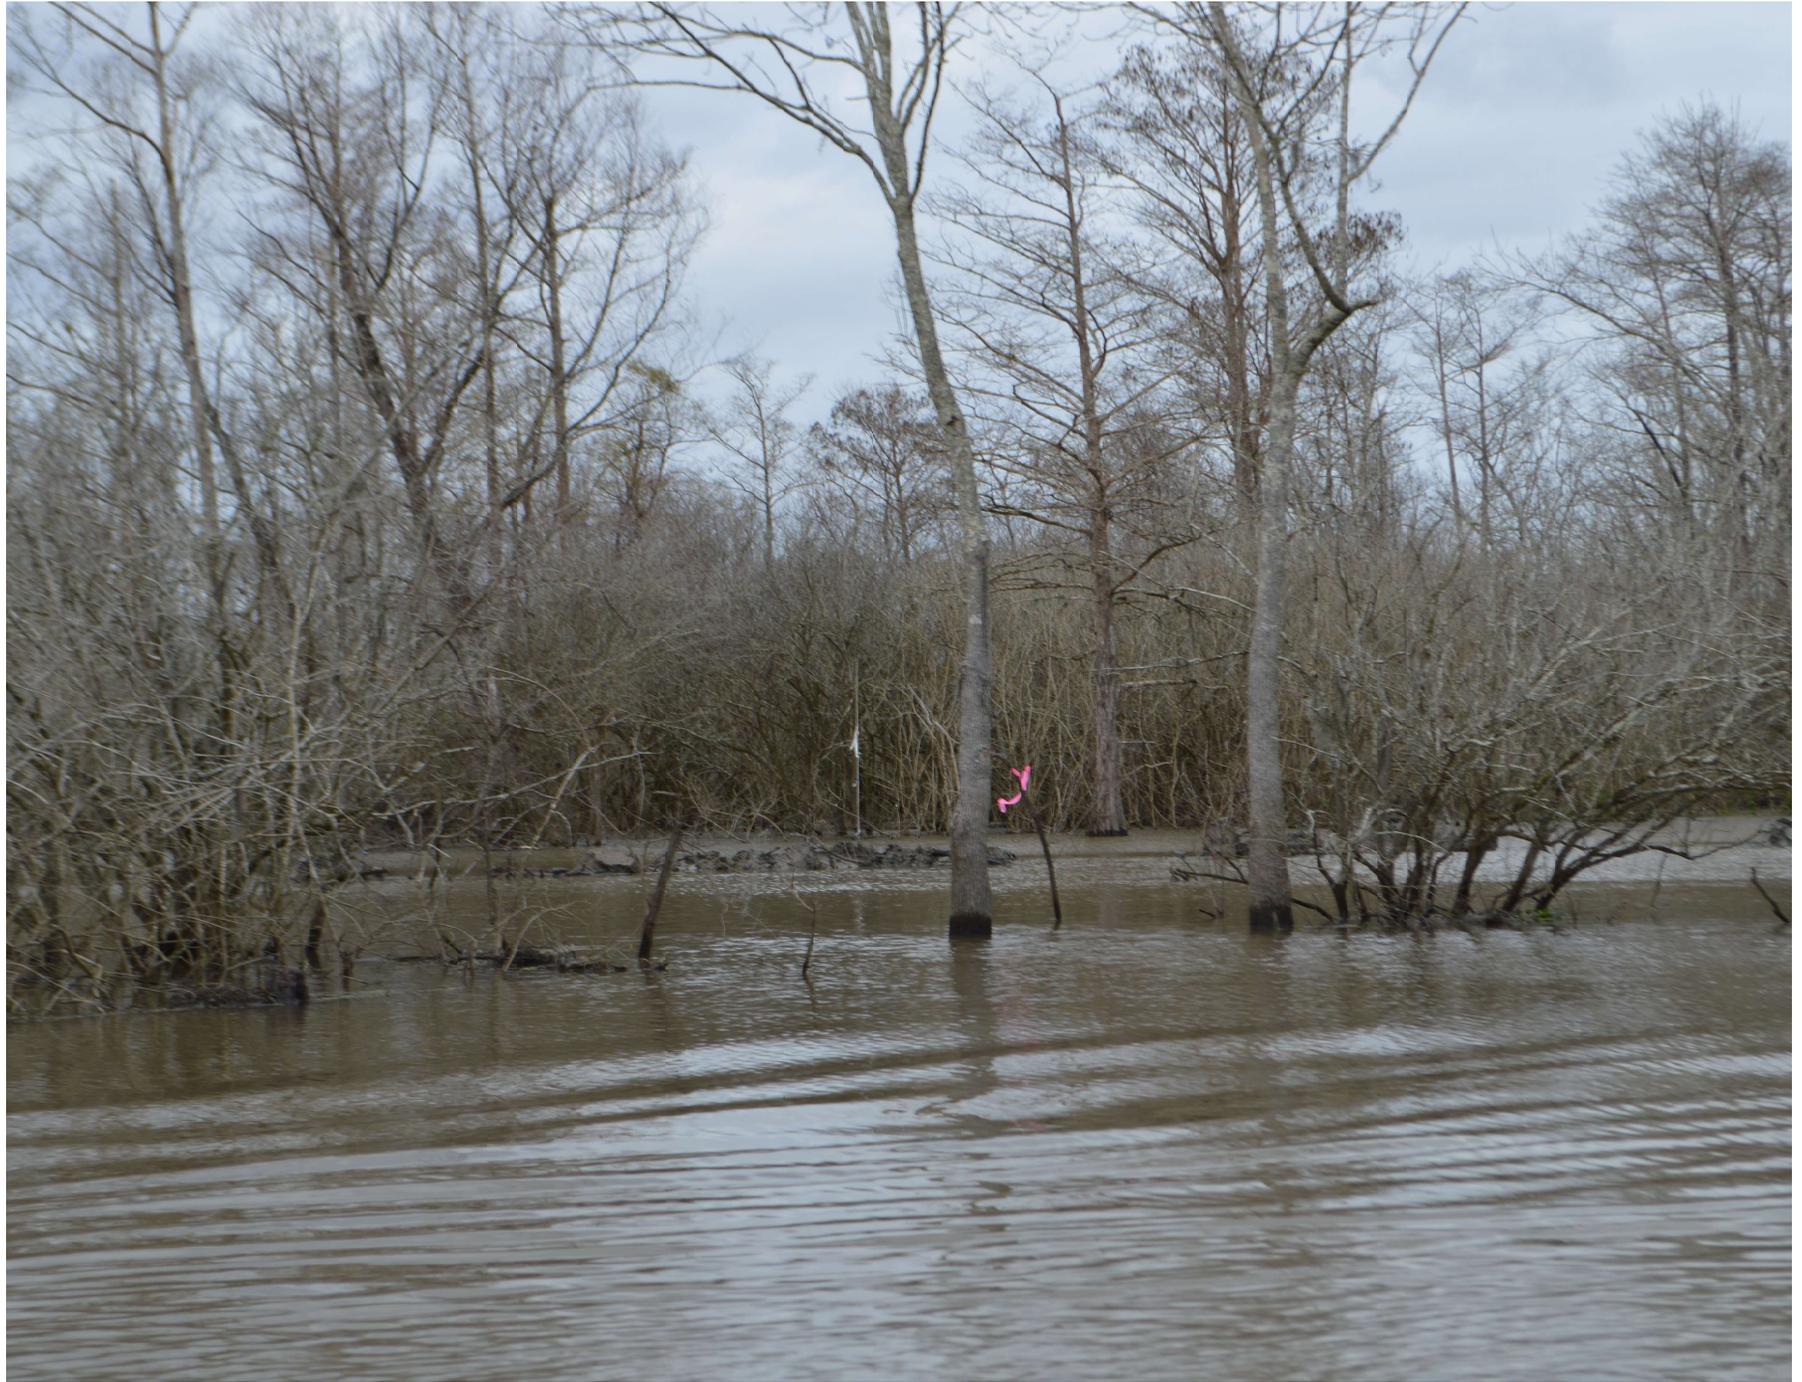
Exhibit 7

- Exhibit 7: January 22, 2019 photograph of spoil bank located at 30° 05'19.61" N, and 91° 22'07.46" W.
- Exhibit 8: January 22, 2019 photograph of a work crew on board a small boat, with a diver located at 30° 05'22.88" N and 91° 21'59.73" W.

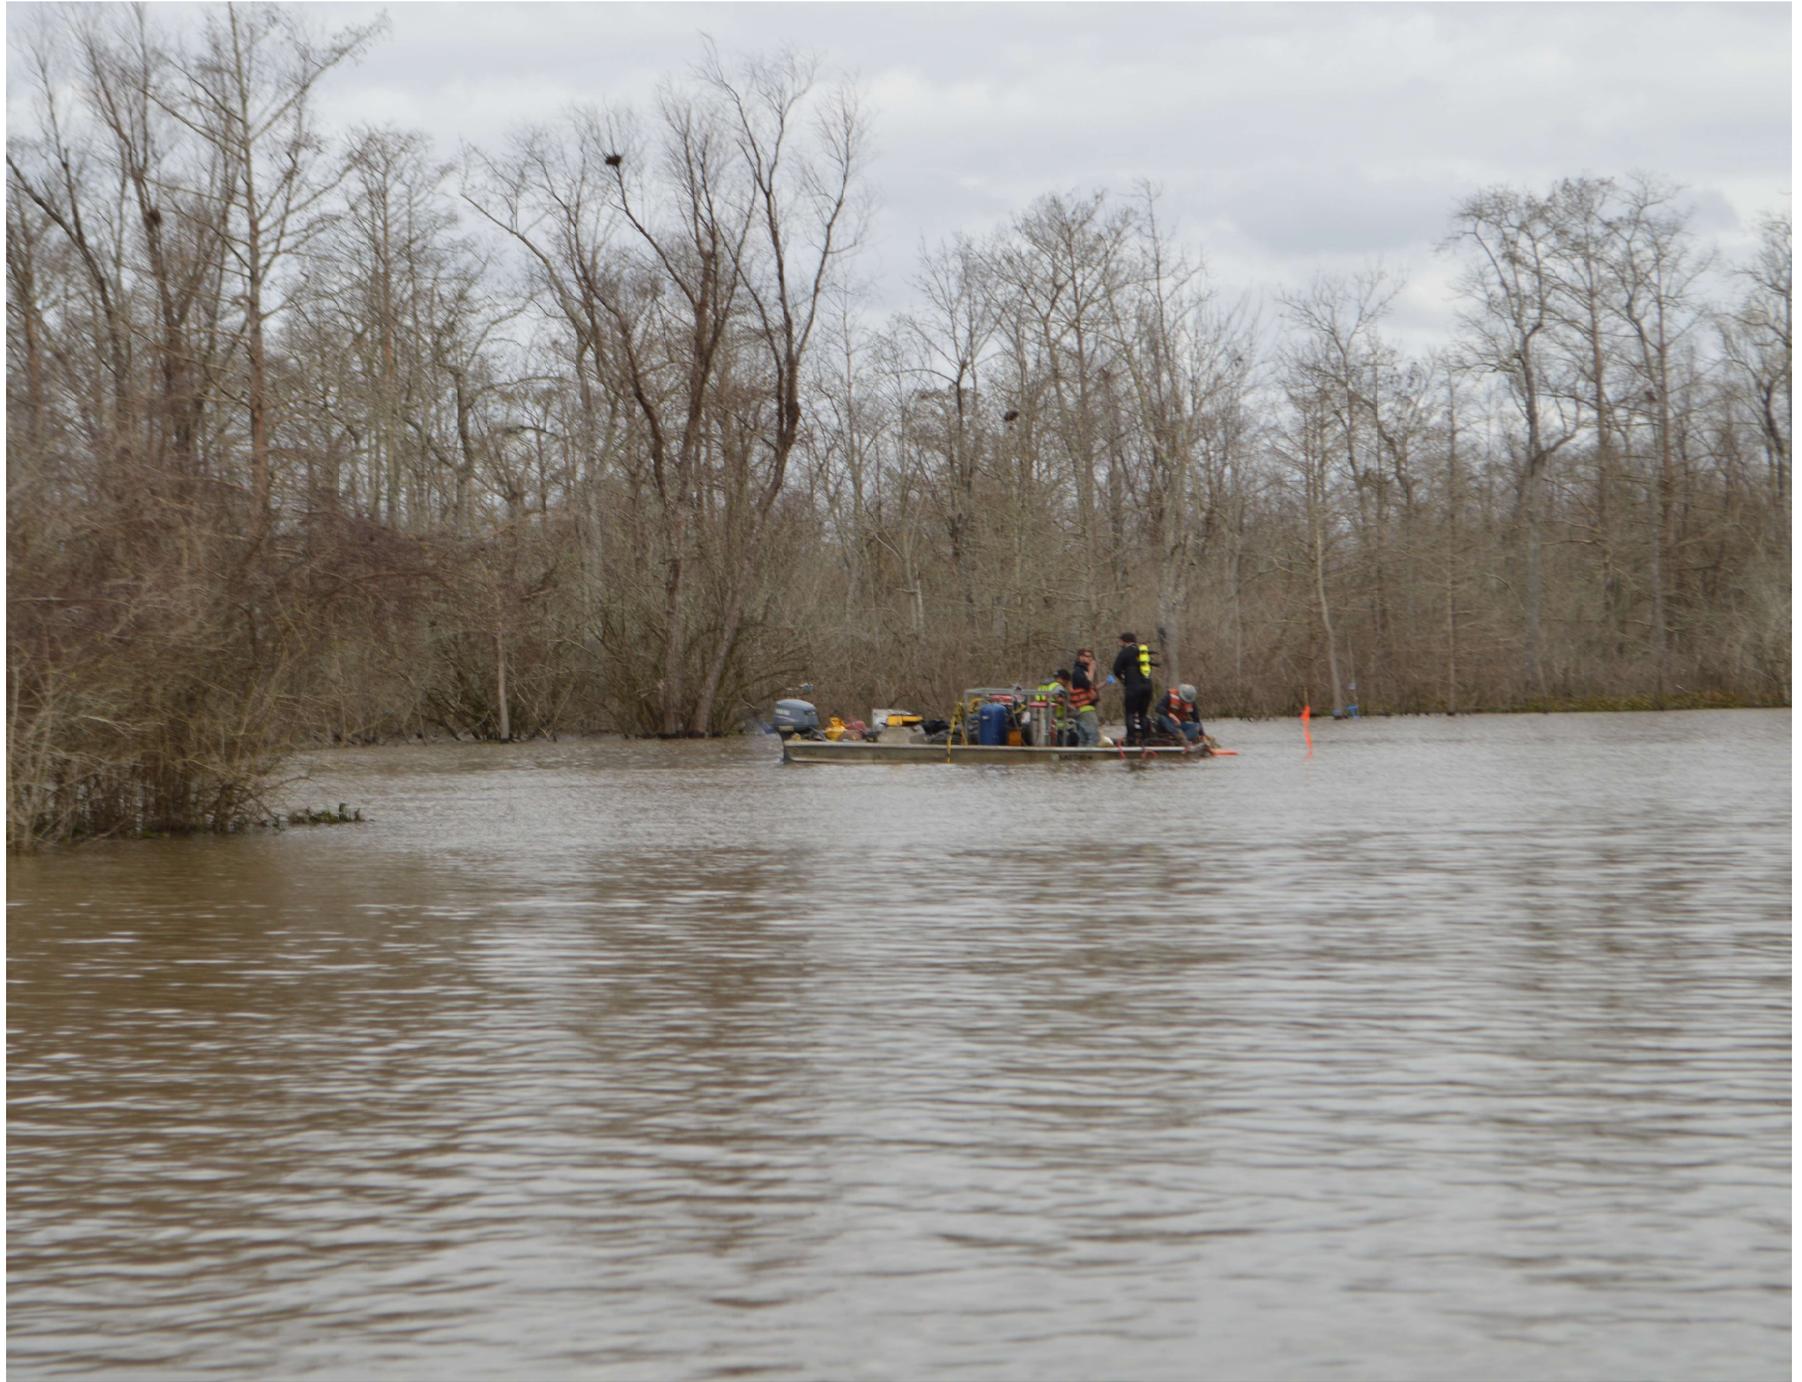
12. Approximately 900 feet away, I also observed a work crew with a diver who appeared to be conducting an underground inspection of the pipeline. Included as Exhibit 8 is a photograph of a work crew on board a small boat, with a diver. I took this photograph on the January 22, 2019, at 30° 05' 22.88" N and 91° 21' 59.73" W.
